# MNM Fatal 2016-01

- Falling, Rolling or Sliding Rock/Material
- February 26, 2016 (Texas)
- Sand and Gravel Mine
- Truck Driver
- 61 years old
- 12 years of experience

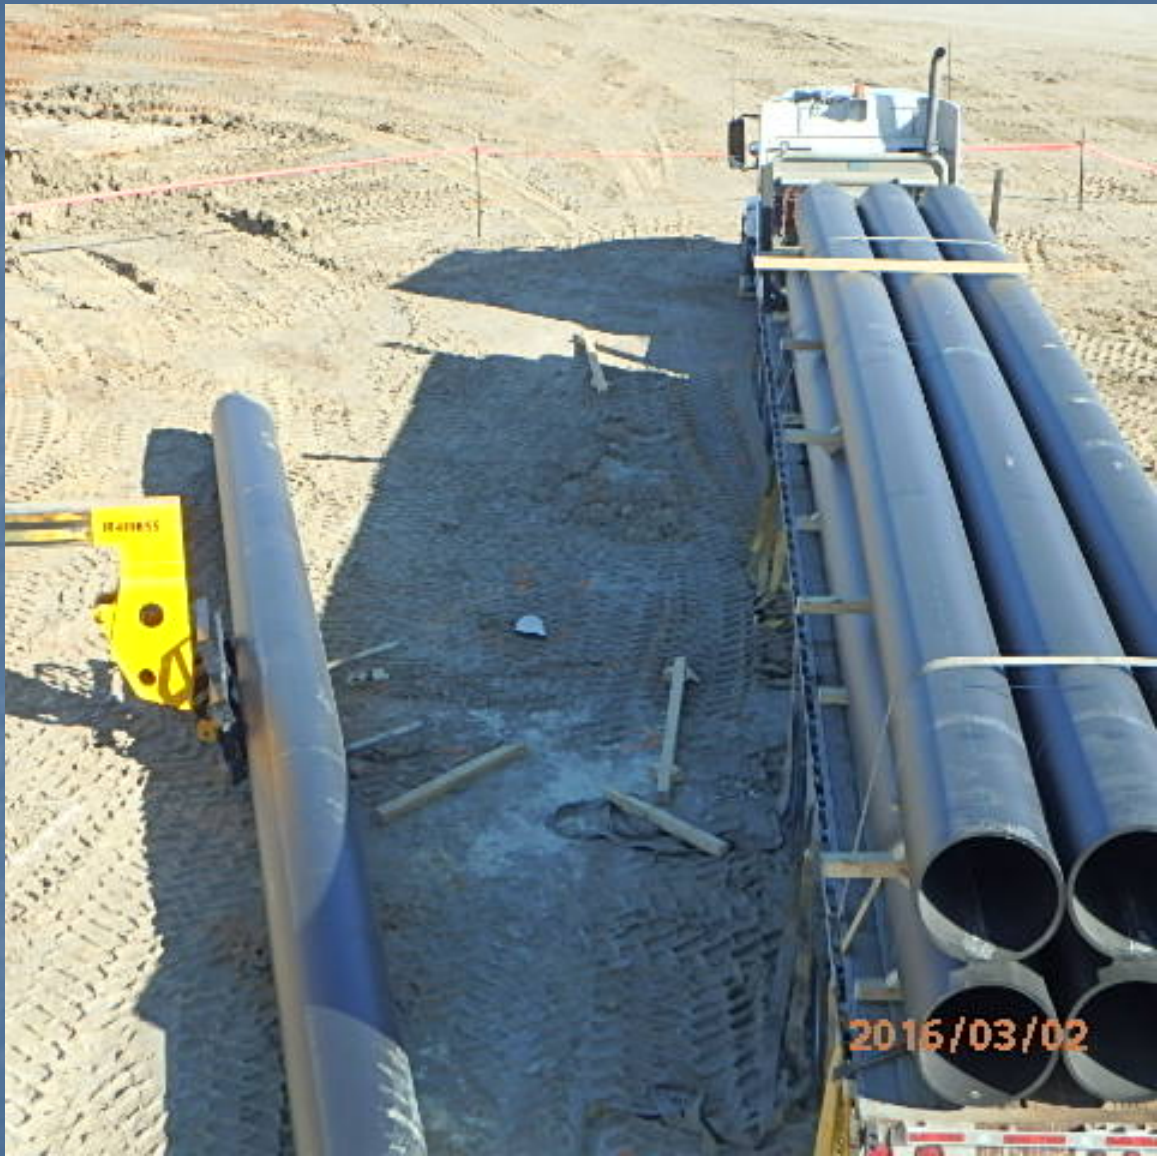
Elvin T. Terrell, delivery truck driver, age 61, was fatally injured on February 26, 2016. Mr. Terrell was in the process of securing the tie down straps on the driver's side of his flatbed trailer when one 50-foot section of pipe rolled off the top and struck him.

The accident occurred because management's policies and controls were inadequate to ensure the unloading of the pipe from the truck was performed in a manner that did not create a hazard to persons.

- Examine work areas during the shift for hazards that may be created as a result of the work being performed.
- Evaluate the stability of the material before unfastening a load. Pay particular attention to loads that may have shifted or become unstable during transport.

- Install secondary supports (side stakes) of adequate height and strength to prevent material from falling when the load is unfastened; or prior to unfastening the material, secure the item being unloaded to the machine used in the unloading process.

- Stand clear of items of massive weights having the potential of becoming off-balanced while being loaded or unloaded.
- Implement measures to ensure persons are properly positioned and protected from hazards while performing a task. Ground personnel should be highly visible. Unauthorized persons should be kept clear of the area
