Mine Safety and Health Administration

Emergency Communication and Tracking Committee
Underground Communication and Tracking Systems Tests at
CONSOL Energy Inc., McElroy Mine

Report of Findings
June 13, 2006

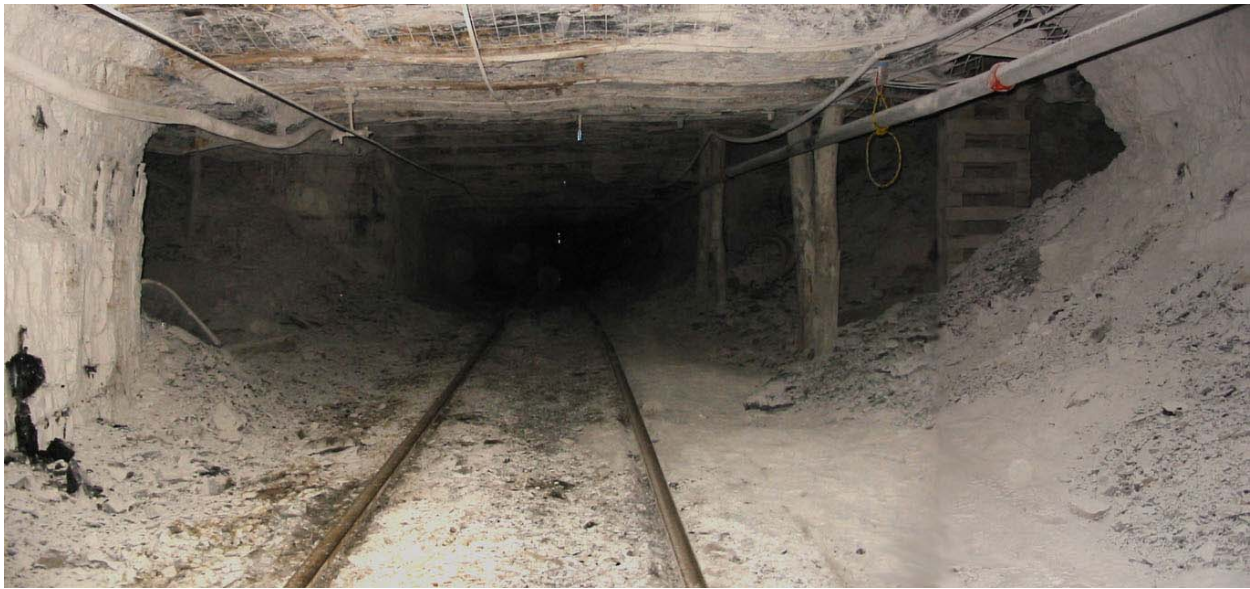
Figure 2: Track Entry

The track entry is also referred to as the #2 entry. The track entry from the #2 belt drive to the S-turn test area was measured to be 18 ft wide and 6 ft high on average (note: S-turn area had an uneven roof as high as 30 ft or more). There was a 2,500-ft section of the entry which led to entries forming an S-turn (over a length of 1,000 ft) on the Fish Creek Portal side. There is metal stopping material in this curve area. The S-turn has an uneven roof-rib due to the fact it intersects a portion of old mine works. There are also pumps, metal jack posts, and other miscellaneous equipment present. True line of sight could not be maintained in the track entry test area due to elevation changes and slight turns. The other end of the entry formed a 120° angle with a 1,600-ft length of entry, which approached the bottom of the Conner's Run Portal slope.

There was a dip in the entry approximately 450 ft from crosscut 2-1 in the area of crosscut 2-6 towards the Fish Creek Portal. The dip area dropped at least ten ft in elevation from crosscut 2-1 and caused the loss of line of sight. Neutral air flowed through the entry. There were several areas of roof spalling and rib sloughage.

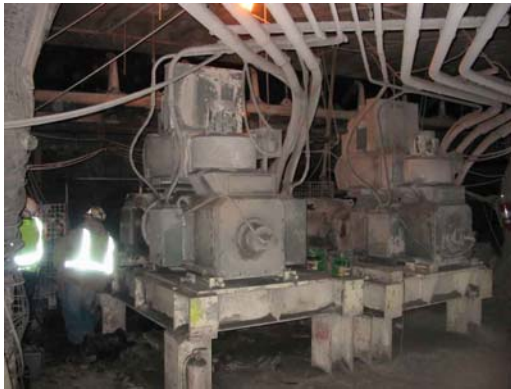
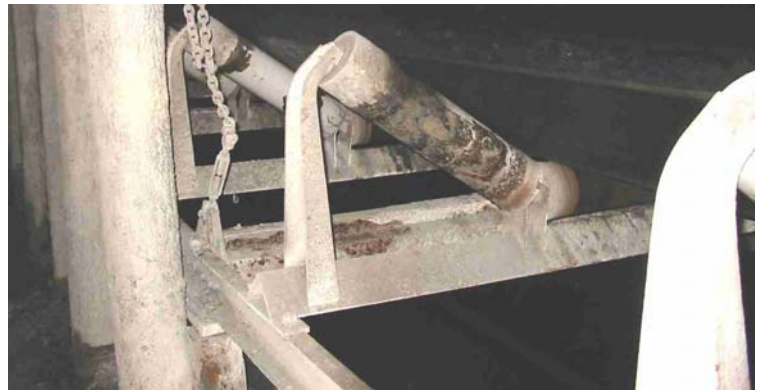
Figure 4: Belt Entry

The belt entry is also referred to as the #1 entry. The belt entry was measured to be approximately 16 ft wide and 6 ft high on average (note: Belt drive area had a roof cut as high as 30 ft). The belt entry in which tests were conducted ran parallel to the previously described 2,500 ft section of track entry. True line of sight could not be maintained throughout the belt entry test area because of elevation changes in the entry and the presence of belt line structures.

Intake air traveled through the entry. There were several areas of roof spalling, and rib sloughage was more prominent in this entry.

The following list comprises the mine infrastructure and potential sources of interference located in the belt entry:

- conveyor belt and belt structure with control lines and switches
- wire mesh belt guards
- high voltage ac cables
- mine page phones and lines
- CO monitoring system
- roof bolts, straps, and wire mesh for roof control
- the #2 belt drive was located at the end of the 2,500-ft length of entry on the Conner's Run Portal side of the test area
- the #3 belt drive was located at the end of the 2,500-ft length of entry on the Fish Creek Portal side of the test area

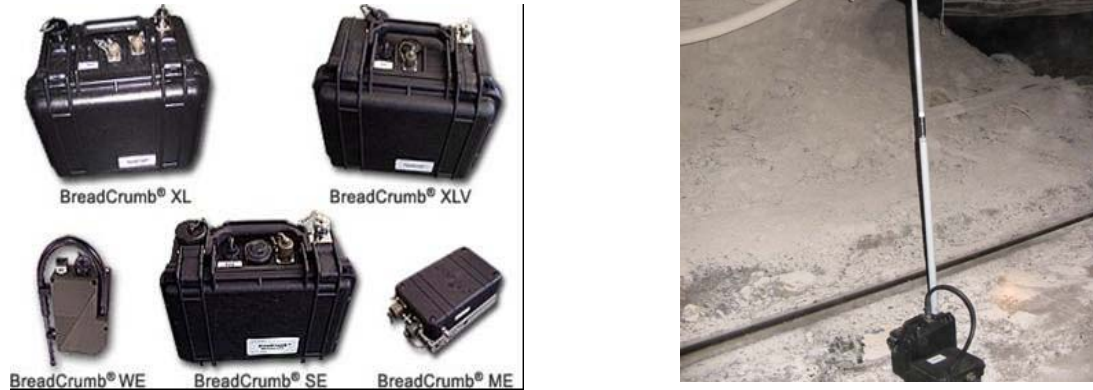
Figure 5: Rajant BreadCrumb™ Nodes

Rajant has developed hardware known as its Breadcrumb™ system that allows the deployment of a fully wireless LAN using the 802.11b protocol, known as WiFi, at 2.4

GHz. This is an ad-hoc mesh network and all nodes are portable and can operate on battery power. Voice communication for this test was through the use of a PDA and laptop PC running Voice Over IP software. Software running on a laptop PC that was connected to the base station node also provided signal strength information. For node to node communication tests, maximum range was exceeded when the signal strength fell below a usable level. Maximum range was then recorded as the distance associated with the point of last usable signal strength. In addition, each node had an LED to indicate whether or not successful network connectivity has been established. Maximum range of the PDA was exceeded when voice or text reception was lost. Maximum range was then recorded as the distance associated with the last successful voice or text communication.

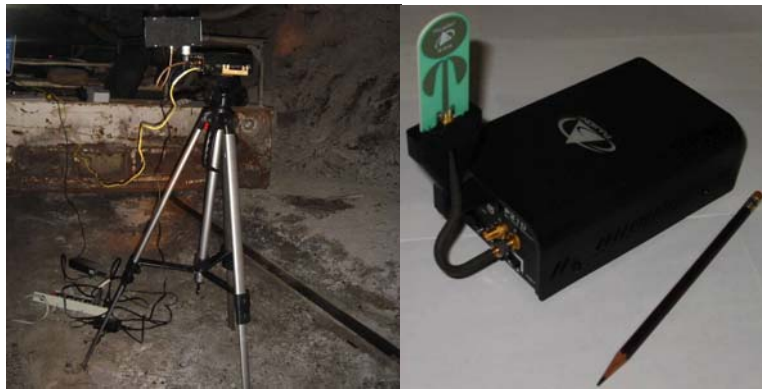
Figure 8: CTC/Time Domain Ultra-Wide Band Radio

The Concurrent Technologies Corporation/Time Domain system is a pulse position modulated Ultra-Wide Band (UWB) radio system with a center frequency of 5.3 GHz and a total bandwidth of 4.2 GHz (from 3.1 GHz to 7.3 GHz) capable of transmitting data, voice, and calculating range from radio to radio using time of flight of the signal. The transmit power of the radios was set at FCC limited power +10 db for this testing. Proprietary software (the Ranging Analysis Module) running on a laptop PC that was connected to a test radio provided range information and signal strength information. For node to node communication tests, maximum range was exceeded when the signal strength fell below a usable level. Maximum range was then recorded as the distance associated with the point of last usable signal strength. For voice communication, a set of radios was modified specifically for this test to run Voice Over IP software. Maximum range during voice communication tests was exceeded when voice reception was lost. Maximum range was then recorded as the distance associated with the last successful voice communication.

Several waveform scans were taken during the various tests to show how the signal changed in different conditions. A spectrum analyzer was also used to monitor and record any background noise present in the test areas.

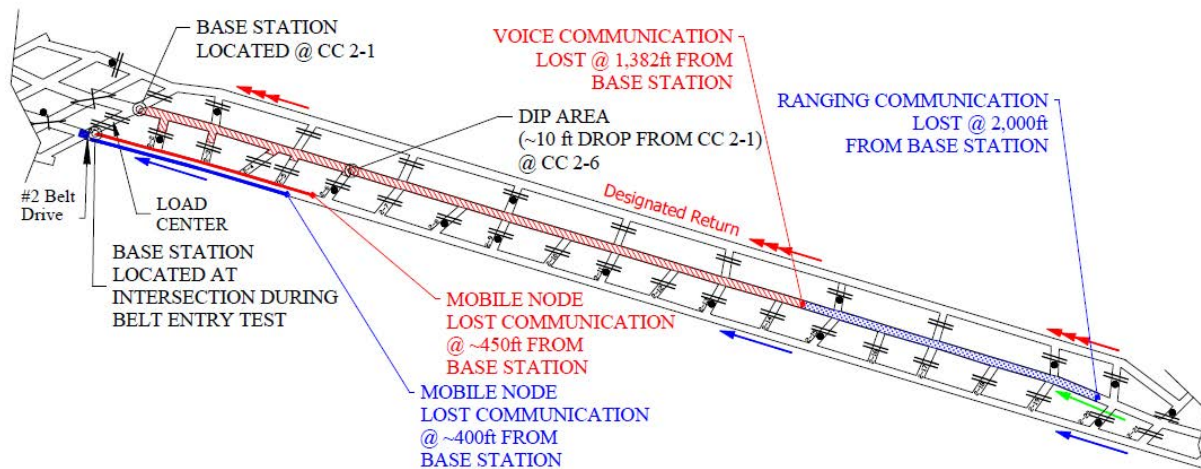
Figure 9: CTC/Time Domain Track and Belt Entry Tests

The base node and a laptop computer were set up at the base station. A mobile node was taken down the track entry while running the Ranging Analysis Module software that is able to calculate range from the base node to the mobile node as well as display signal strength information. The UWB radios demonstrated uninterrupted reception out to 1,200 ft, and a maximum range of approximately 2,000 ft with some dead spots. Both of these ranges were achieved through the dip area. Omni-directional antennas were used out to a range of 950ft and then a directional antenna was installed on the base station radio. Although not included in this test system, Time Domain stated that in a final design voice could be received at any point that range data is available.

The range information provided by the UWB radios was compared to the distance as measured by the Rolatape wheel. It was found that the two measurements were within 10 ft of each other out to 1,000 ft and within 21 ft of each other between 1,000 ft and 2,000 ft.

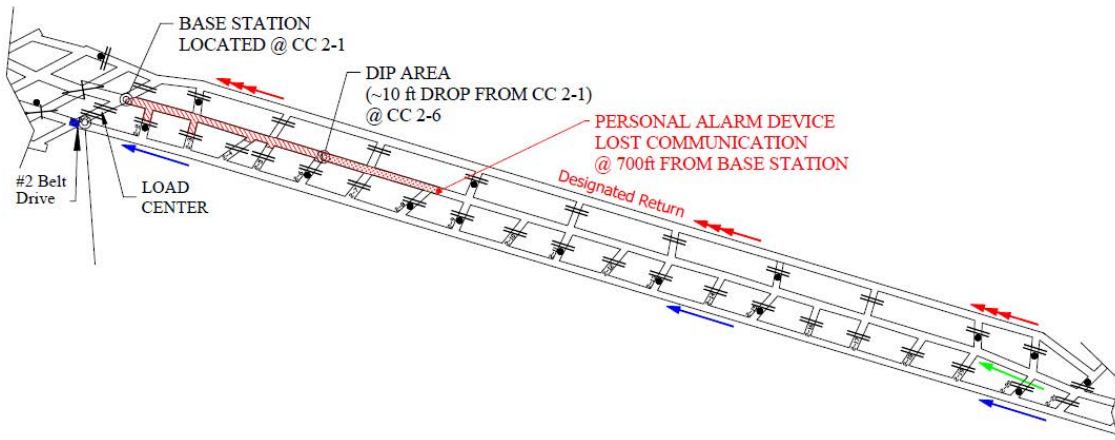
Figure 14: Gamma Services Track Entry Test

The signal from the PAD was received at a distance of 700 ft from the base station when going through the dip area. Once the base station was moved to the Fish Creek Portal side of the dip, the PAD signal was maintained through a distance of 1,012 ft.

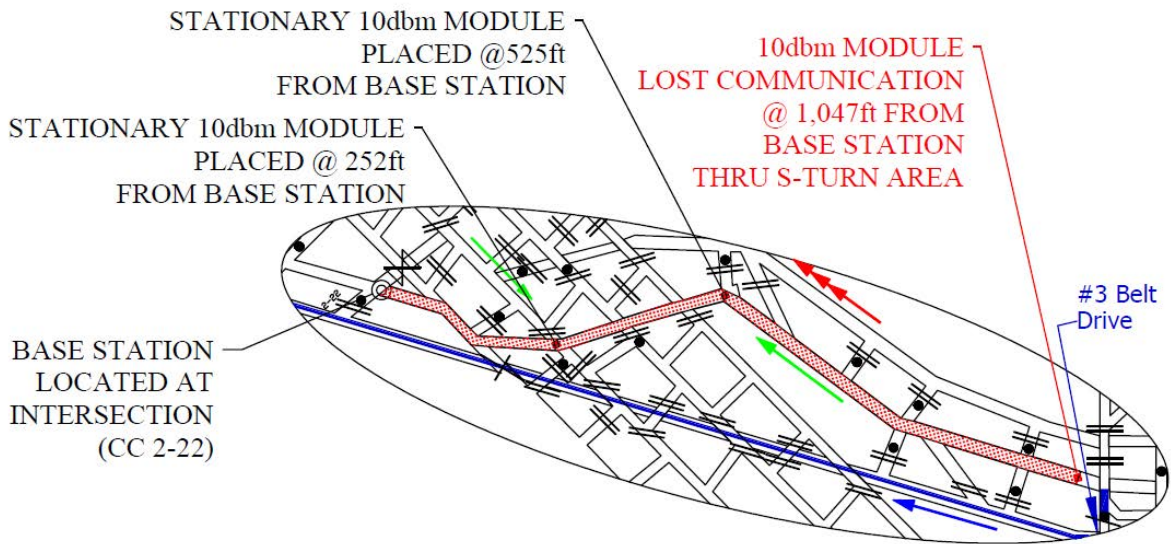
Figure 21: Innovative Wireless Technologies S-Turn Test

Four nodes were required to propagate a signal through the S-turn section of the track entry. One node was located at the beginning of the section, two nodes were spaced apart in the middle, and one node was located at the end of the 1,000 ft section.

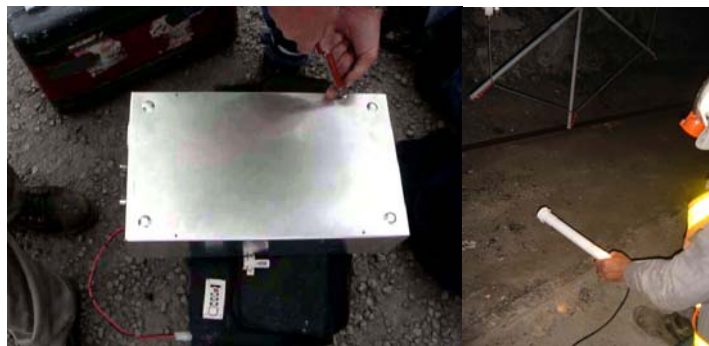
Figure 23: Kutta Consulting SWECS

The SWECS is a two-way voice and data communication system being developed for the U.S. Army under a Small Business Innovative Research contract. Voice and data are transmitted between radios using Medium Frequencies (<3 MHz). Three different frequencies were tried during this testing as well as both loop and ferrite rod antennas (both of these antenna types are directional). Also tested was a radiolocation beacon that operated at Very Low Frequency (<10kHz) and sent a continuous tone. During in-mine testing, maximum range was exceeded when voice communication between radios was lost. Maximum range was then recorded as the distance associated with the point of last voice communication. Through the earth testing would have been successful if voice communication was established between the two SWECS radios. Through the earth testing of the radiolocation beacon was successful when the beacon tone could be heard through a receiver located on the surface.

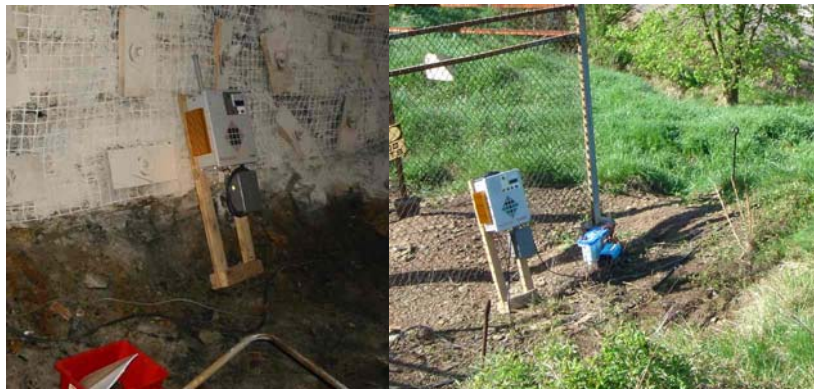
Figure 27: Transtek Telemag Unit; Underground and Surface @ 270'

The Telemag through-the-earth voice communication system consists of two transceiver units with loop antennas (antennas are directional). Each transceiver unit is equipped with two individual loop antennas. One loop antenna is used for receiving and the other loop antenna is used for transmitting. The transceivers use single side band modulation with comb filters to attenuate noise from 60 Hz power sources. The transmission system is half-duplex which allows communications in both directions, but only one direction at a time (not simultaneously). This system operates in the Very Low Frequency range between 3,000 and 8,000 Hz. This radio frequency range readily propagates through the earth.

One transceiver unit and antenna is located in the underground mine and the other transceiver unit antenna is positioned on the surface directly over the corresponding underground loop antenna. The system does not have signal locating capabilities so the surface and underground positions must be known before the communication system is set up. Once communication is established, the surface antenna can be repositioned for optimal signal quality. Through-the-earth testing was successful when voice communication was established between the two radios.
