Quarterly Stakeholder Call

April 30, 2018

U.S. Department of Labor
Mine Safety and Health Administration

Powered Haulage Safety Initiative

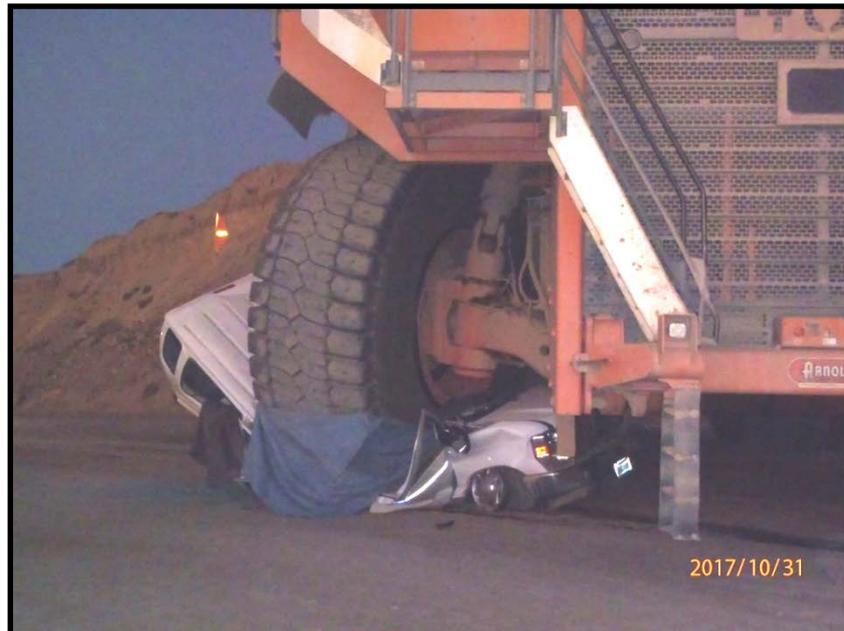
Haul Truck vs Passenger Van

A 340-ton haul truck ran over a passenger van carrying nine miners on October 31, 2017. The driver of the van and the miner in the front seat were fatally injured. Of the remaining seven miners, one suffered a non-life threatening injury.

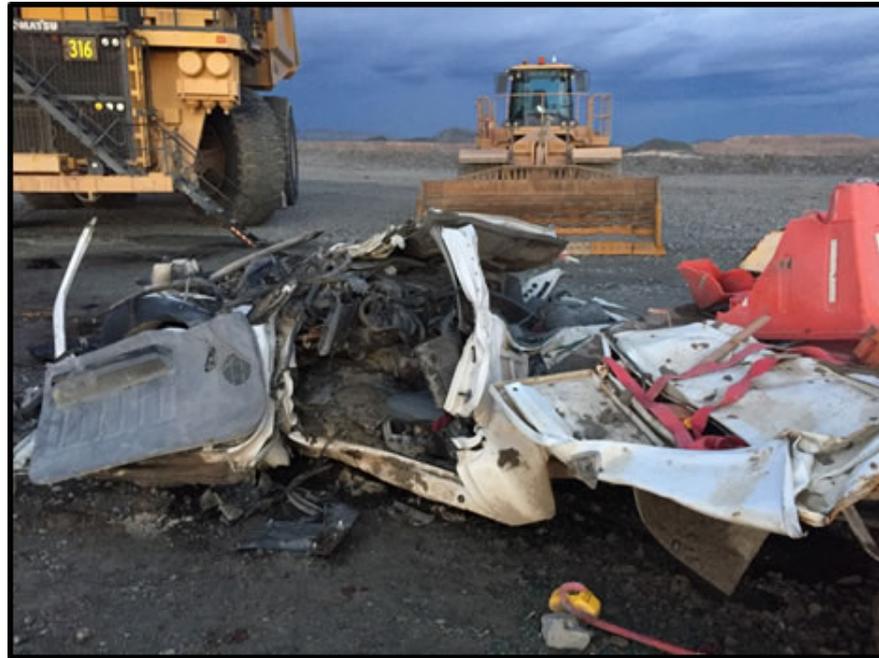
Haul Truck vs Light-Duty Truck

A miner was fatally injured when his light-duty truck was run over by a haul truck on July 27, 2017. The victim was pronounced dead at the scene.

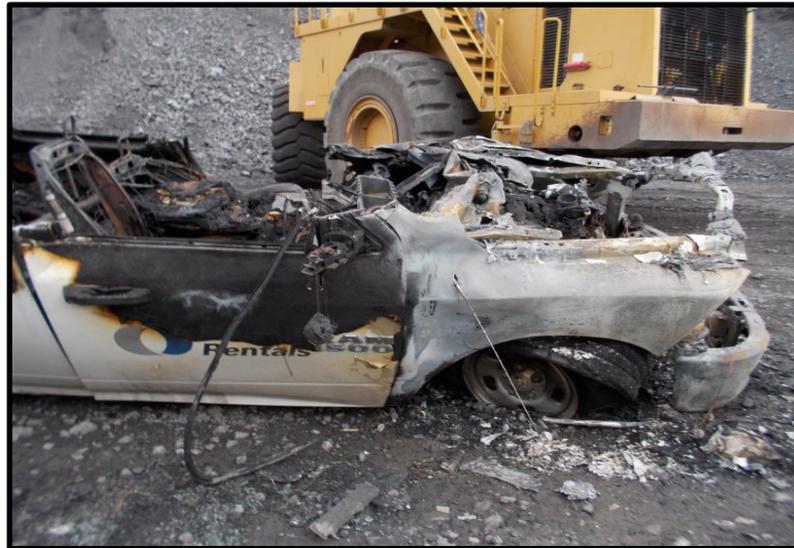
Front End Loader vs Pickup Truck

An employee in a pickup truck approached the quarry loadout area to get the Front End Loader (FEL) operator for lunch on December 30, 2017. The FEL operator backed into the pickup, pushing it sideways and crushing the driver's side of the pickup cab, trapping the victim inside the truck. The pickup truck caught fire and efforts by the FEL operator and a nearby contractor to put the fire out using fire extinguishers were not successful.

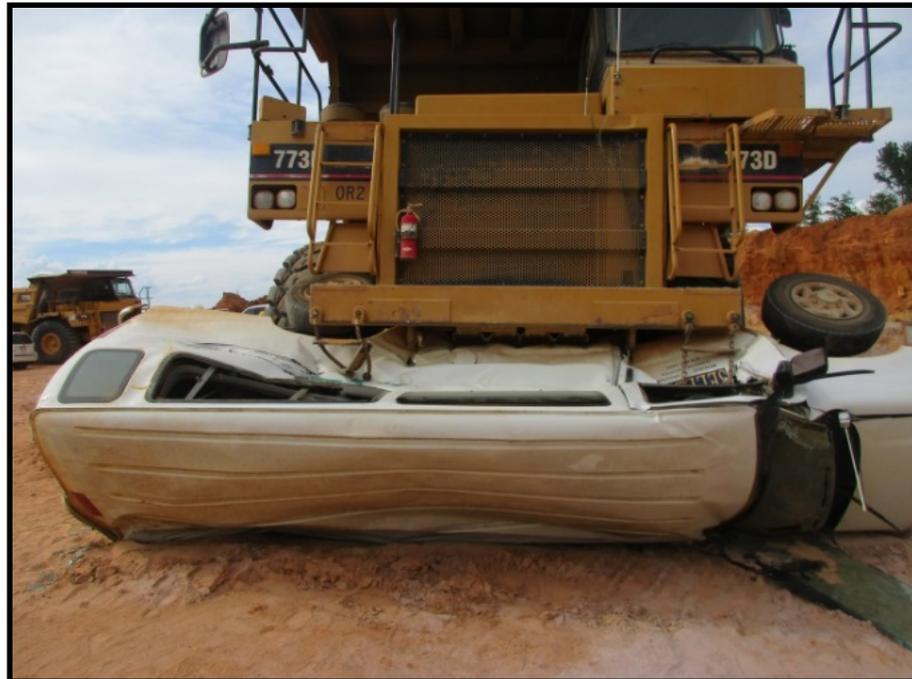
Haul Truck vs Supervisor's Van

A haul truck driver traveled into the pit loading area on June 19, 2017 and parked 30 feet from a supervisor's parked van. When the loader operator sounded a horn notifying the haul truck to move into position for loading, the driver moved forward, pushing the supervisor's van 30-40 feet. The supervisor exited the van through the window and was uninjured.

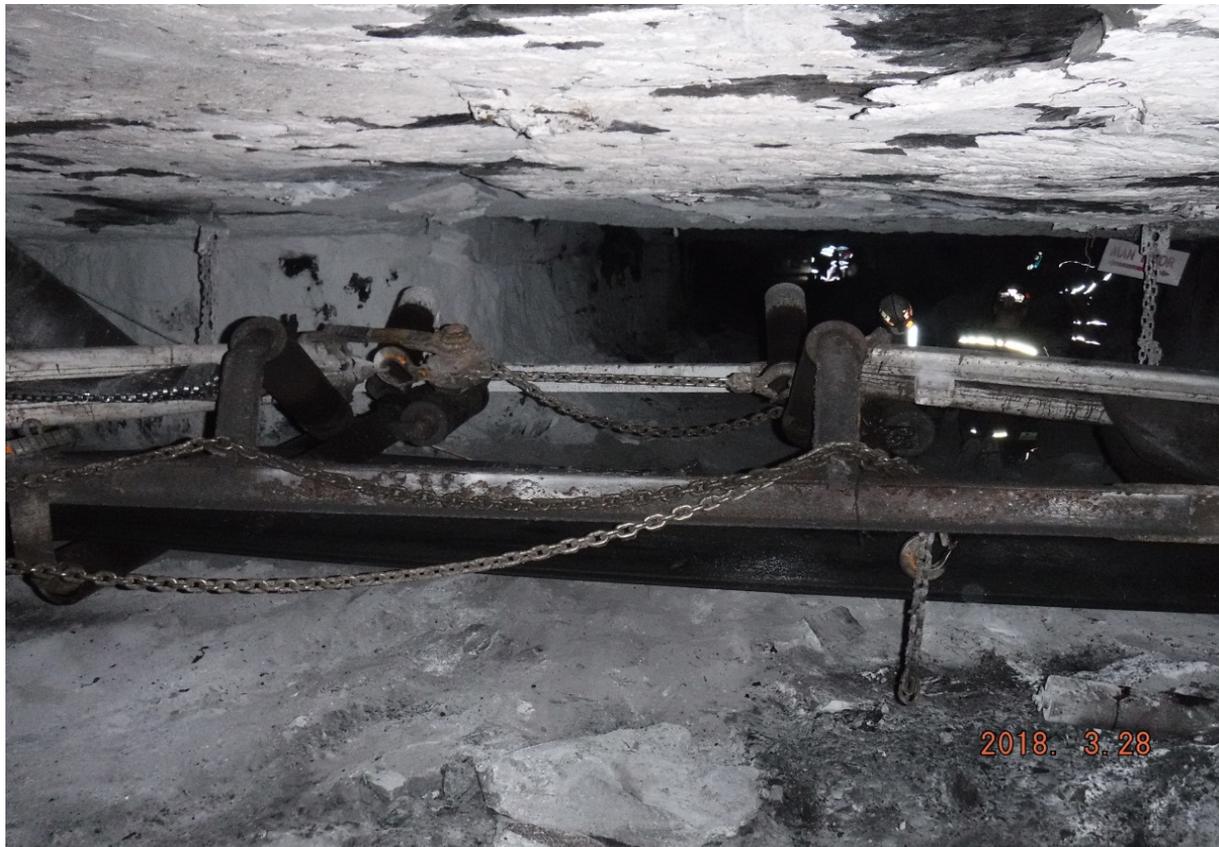
Lock-Out/Tag-Out

A belt foreman was fatally injured on March 28, 2018, when the conveyor belt inadvertently started as he and a co-worker were in the process of splicing an underground conveyor belt. The victim became entangled with the belt splicing tools as the conveyor belt moved.

- Before splicing conveyor belts:
 - Open the circuit breaker that supplies electrical power to the belt drive.
 - Open the visual disconnect for the cable that supplies electrical power.
 - Lock-out and tag-out the visual disconnect yourself and NEVER rely on someone to do this for you.
 - Release the tension in the conveyor belt take-up/storage unit.
 - Block the conveyor belt against motion.
- Ensure that no miner is in harm's way before starting the conveyor belt.
- Provide a visible and/or audible system, with a start-up delay, to warn persons that the conveyor belt will begin moving.
- Establish policies and procedures for performing specific tasks on conveyor belts and ensure all miners are trained.

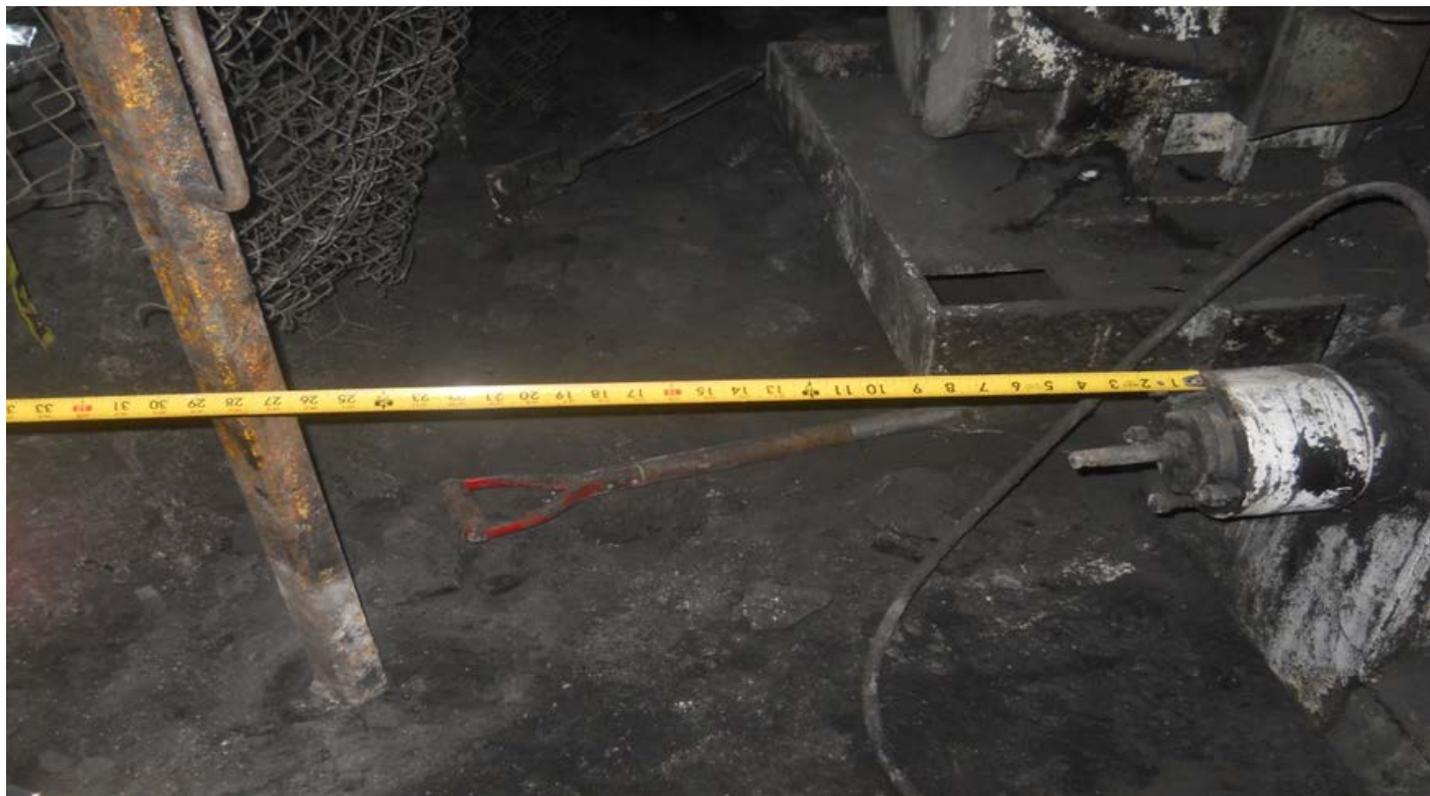
Proper Guarding

A miner was fatally injured on January 26, 2017 when he contacted a moving drive roller for the section belt. The victim was positioned between the guard and the conveyor belt drive when he came in contact with the shaft of the belt drive roller.

- All belt drives should have adequate guarding, without doors intended to be removed while equipment is running.
- Whenever guarding is removed to perform work, belt drives must first be de-energized and blocked against motion. All employees should be trained in these procedures and a lock and tag should be provided to miners who work on conveyor belts.
- All employees working around moving conveyor belts and their associated components should be trained in hazard recognition and avoidance.
- In addition, persons conducting examinations should be trained to perform thorough examinations to identify hazards.

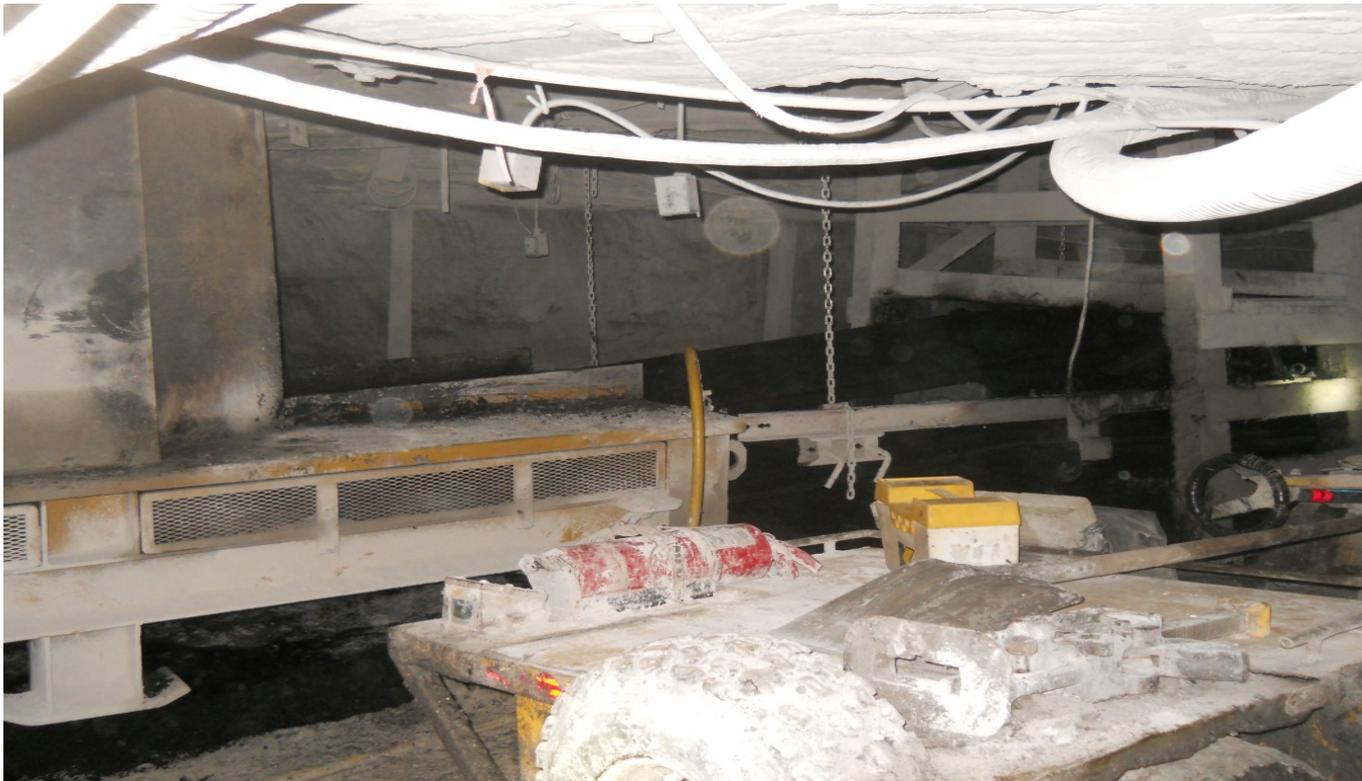
Crossovers

A mine examiner was killed when he apparently lost his footing attempting to cross over a moving conveyor belt on August 25, 2017. He fell on to the belt and hit a belt crossover located approximately 10 feet away. The victim was found beside the conveyor belt just outside the mine entrance.

- Install adequate crossovers at all belt transfer points and train miners to use them. All crossovers, mid-belt crossovers, and crossunders should be evaluated and modified as appropriate.
- Install barriers at strategic locations at belt transfers to block areas that can be used to improperly cross the belt.
- Install a visual and audible pre-start alarm that signals several seconds before the start up of the belt.
- Install pull cords and switches that control power to the conveyor belt to stop the conveyor belt in emergencies. Switches may be hung across the conveyor belt.

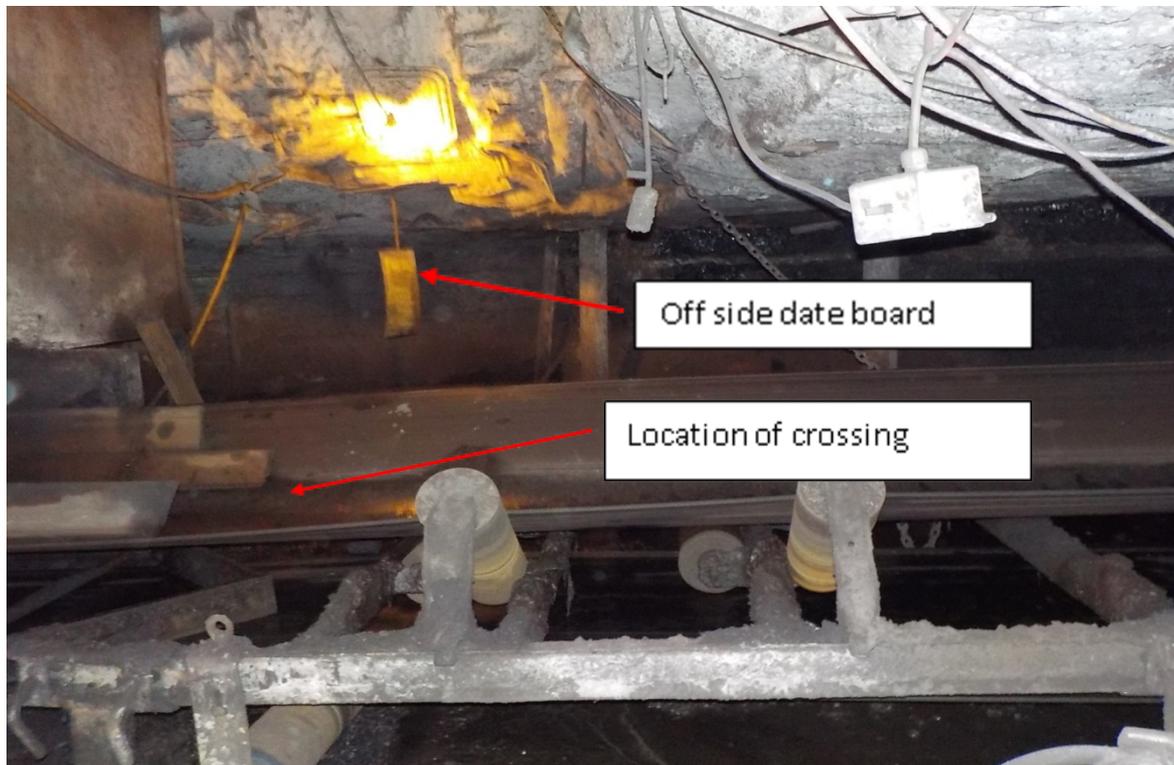
Crossovers

A mine examiner received fatal injuries after he fell on to a conveyor belt while apparently attempting to cross it on October 23, 2017. He was transported by the belt conveyor system to the raw coal pile located outside of the mine.
