MSHA Safety Alert

Nondestructive Testing & Wire Rope Examinations

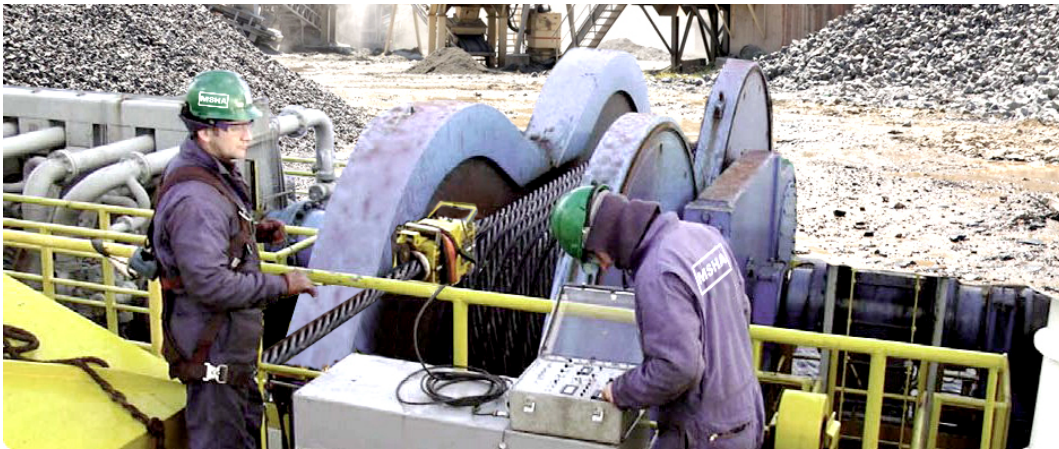
MSHA conducted wire rope nondestructive testing (NDT) and inspections on hoisting ropes that had been determined safe for service as a result of a recent examination and found that these ropes had flaws and no longer met MSHA's in-service standards. Therefore, MSHA is recommending that mine operators use NDT when conducting required six month inspections of wire ropes. NDT equipment utilizes magnetic or ultrasound waves to view the inner workings of the rope without cutting into it, much like a CT scan or MRI. Loss of metallic area, flaws (broken wires and corrosion) and strength loss can be evaluated through NDT for the entire active length of a hoist rope. The following are best practices for mine operators to maintain wire ropes, including conducting nondestructive testing and examinations:

- Conduct wire rope NDT at least once every six months to identify deterioration including: wear, corrosion, distortion, broken wires and loss of metallic area.

- Review the wire rope NDT results to identify deteriorated portions of the wire rope that shall be visually examined more frequently.
- Examine daily any portion of the wire rope where a reduction of rope strength is present.

- Conduct wire rope examinations during daylight hours.
- Perform visual examinations at a rope speed no more than 50 fpm.
- Clean and remove old lubricant to conduct a thorough visual wire rope examination especially in high stress sections.
